# Innovations in Inspection and Monitoring Techniques for High Temperature Plant

*Ahmed Shibli*

*European Technology Development Ltd. (ETD), Surrey, UK*

# Development of Innovative Inspection and Monitoring Techniques

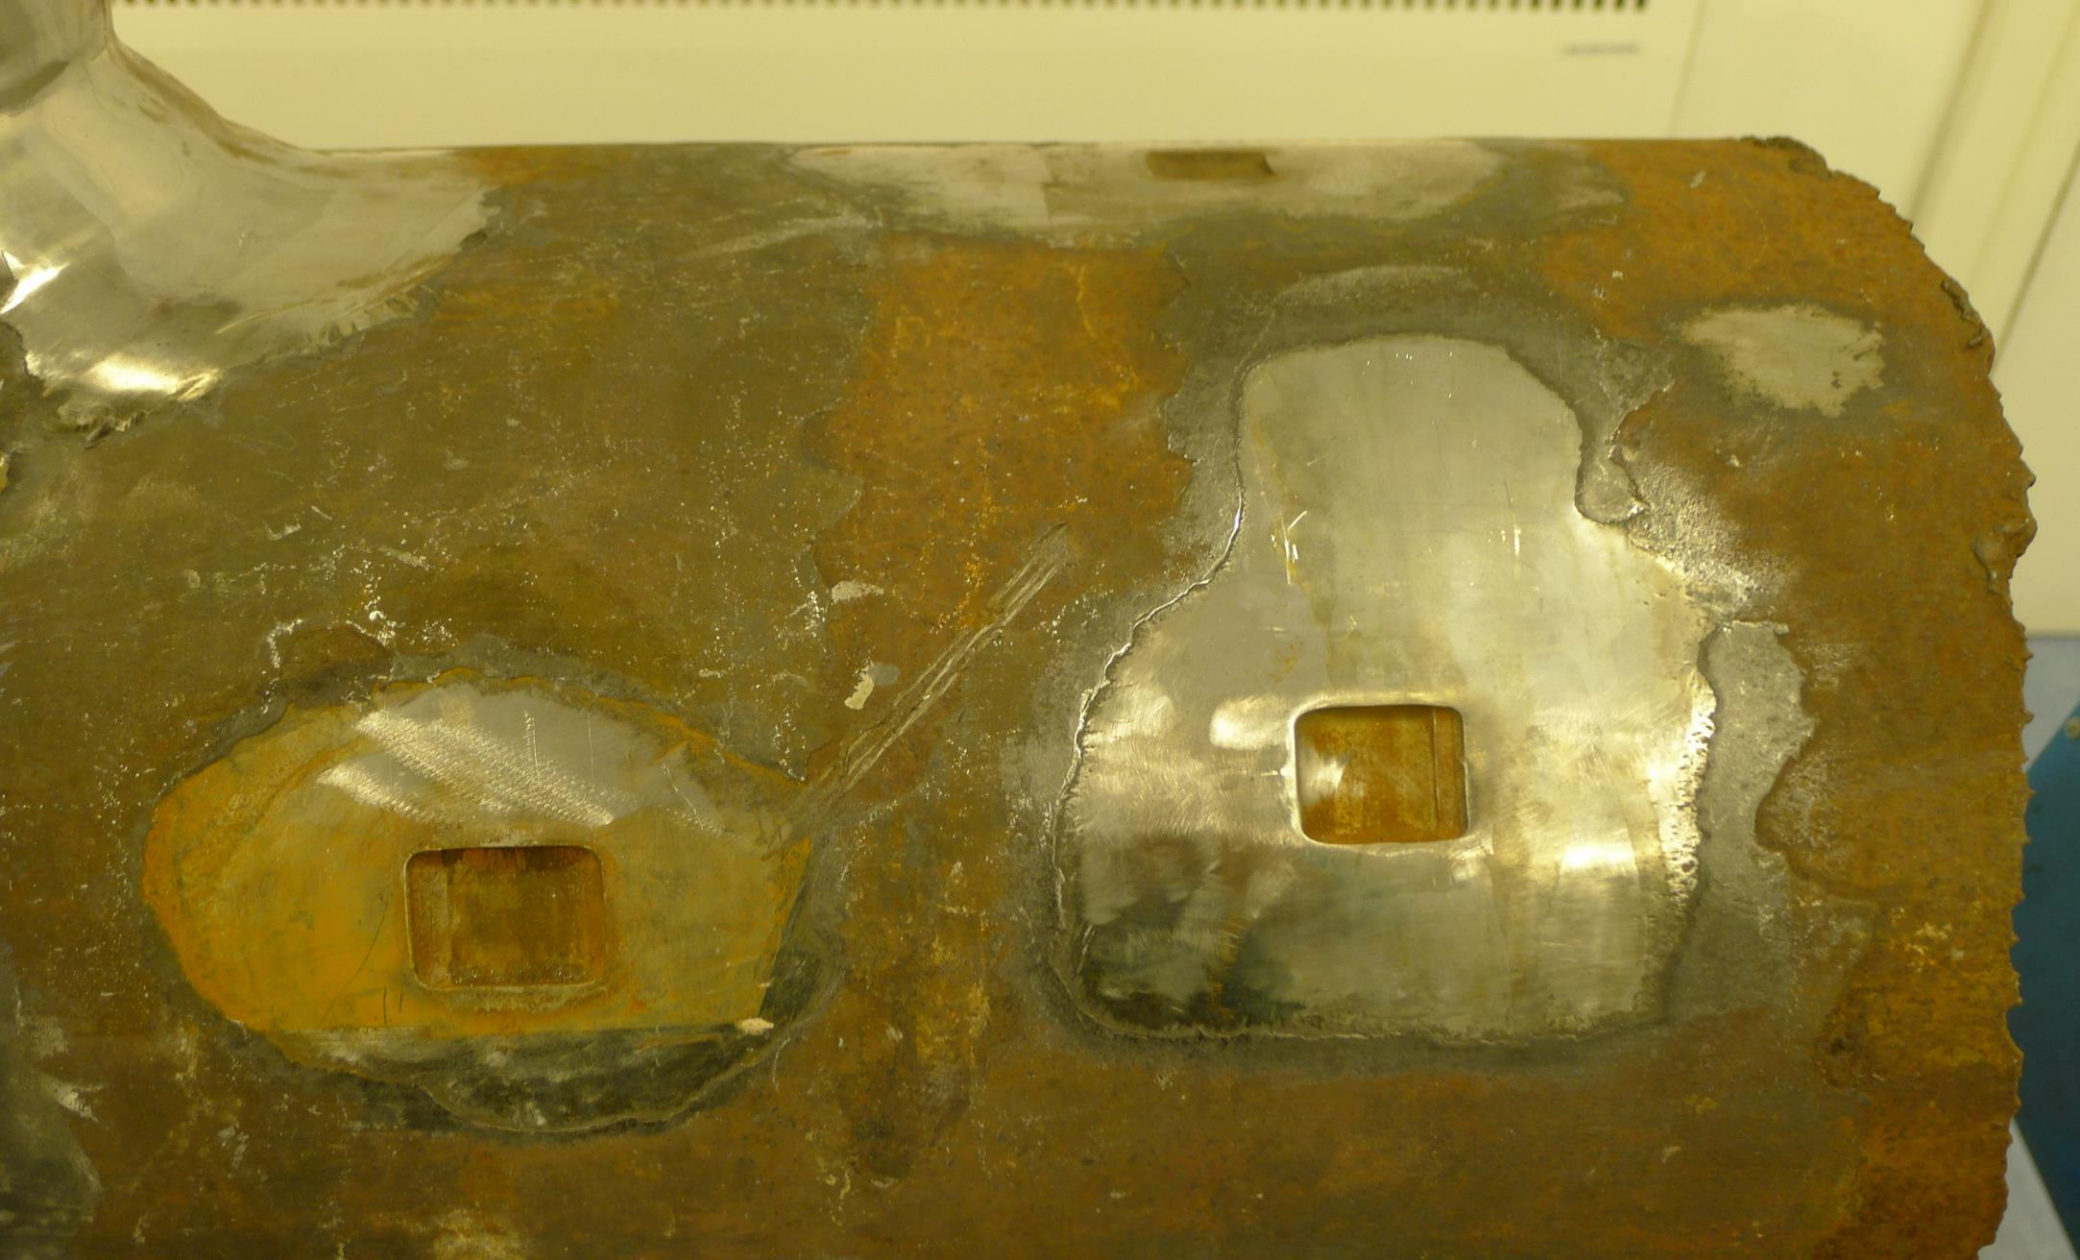
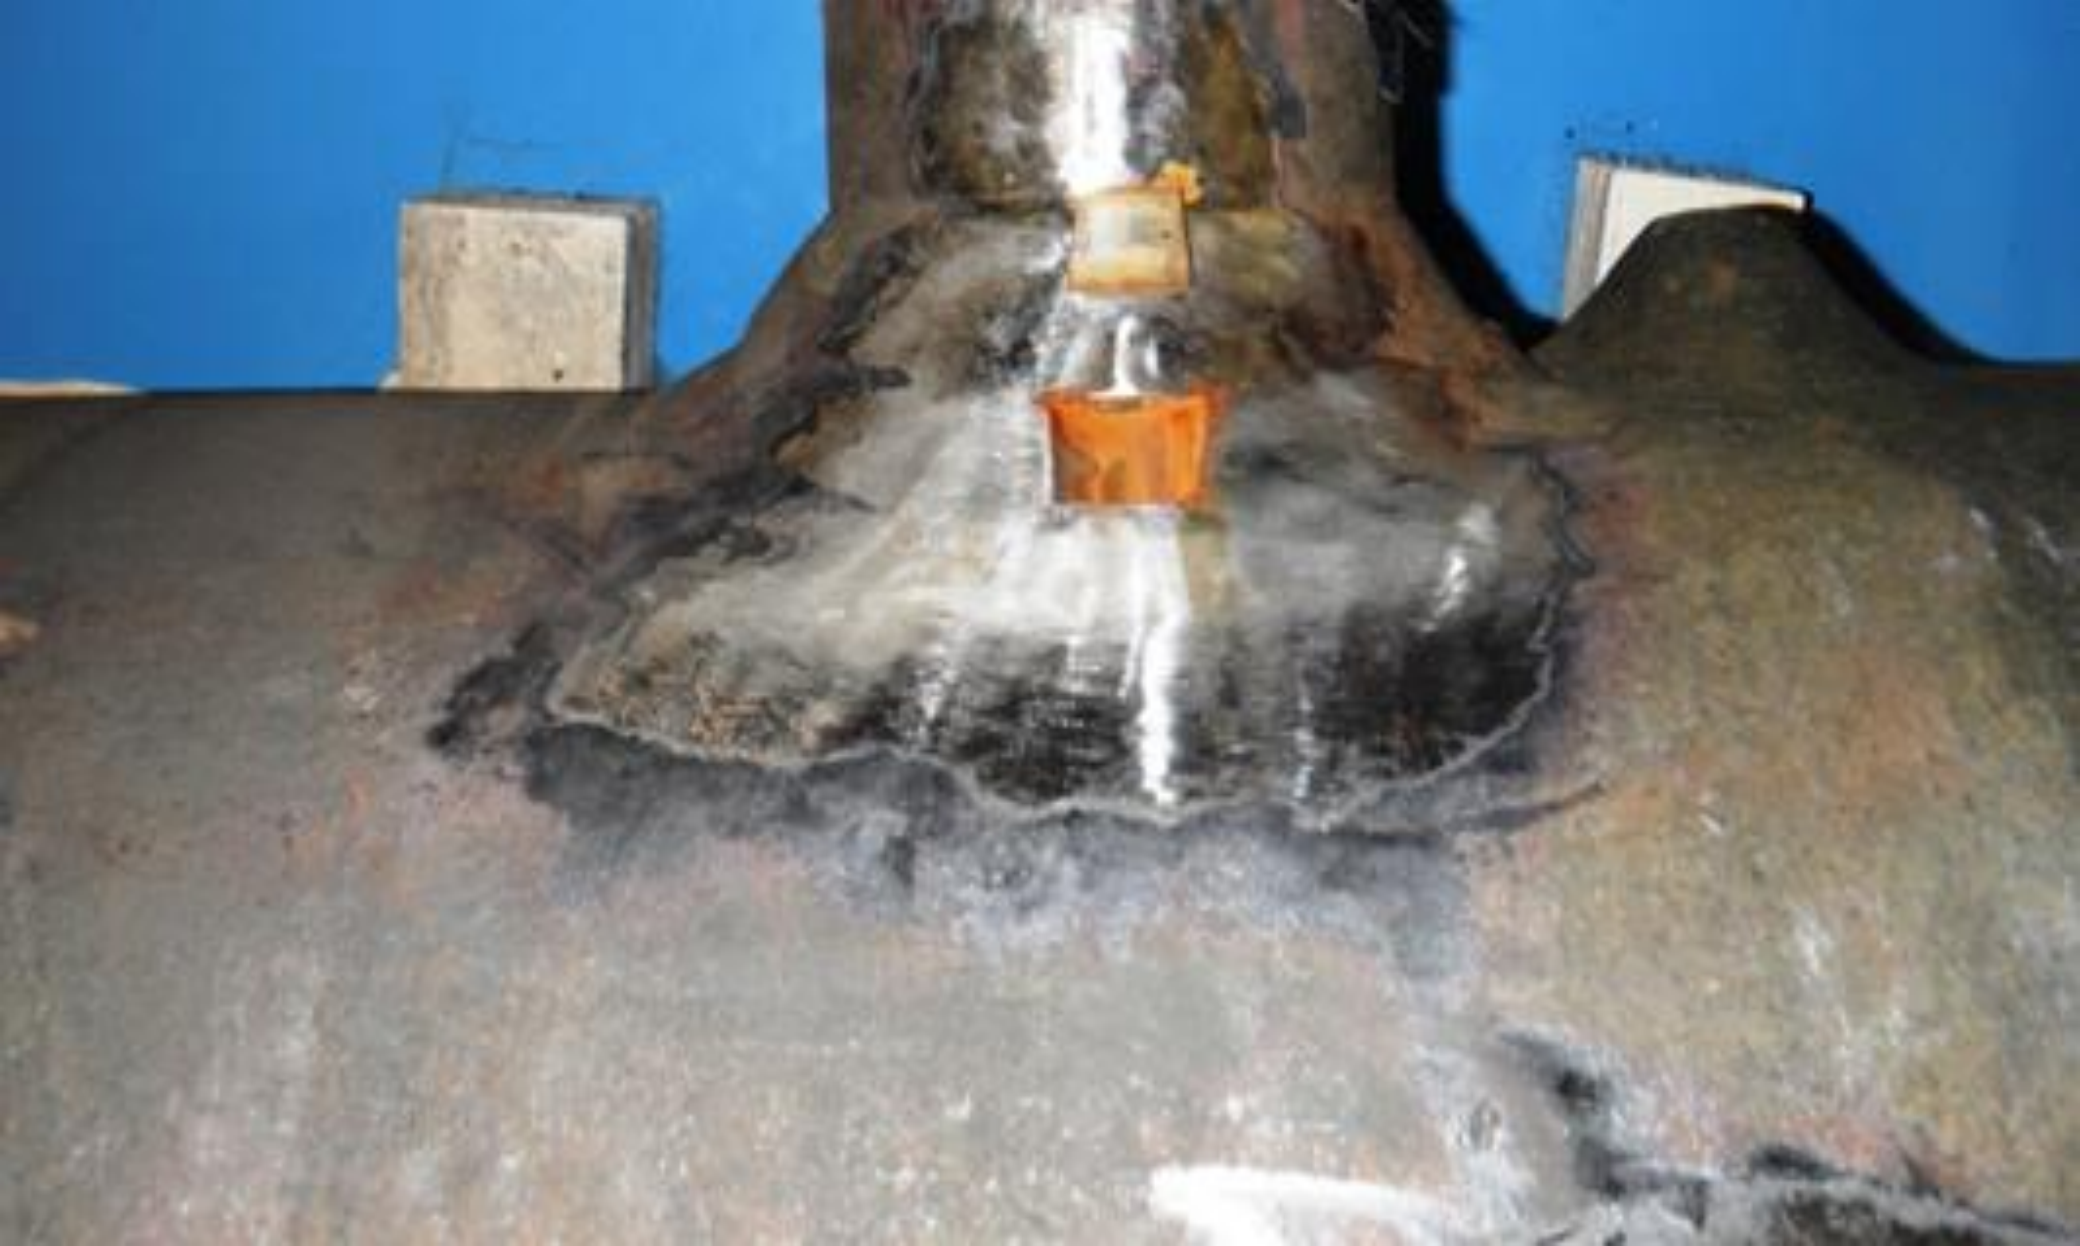
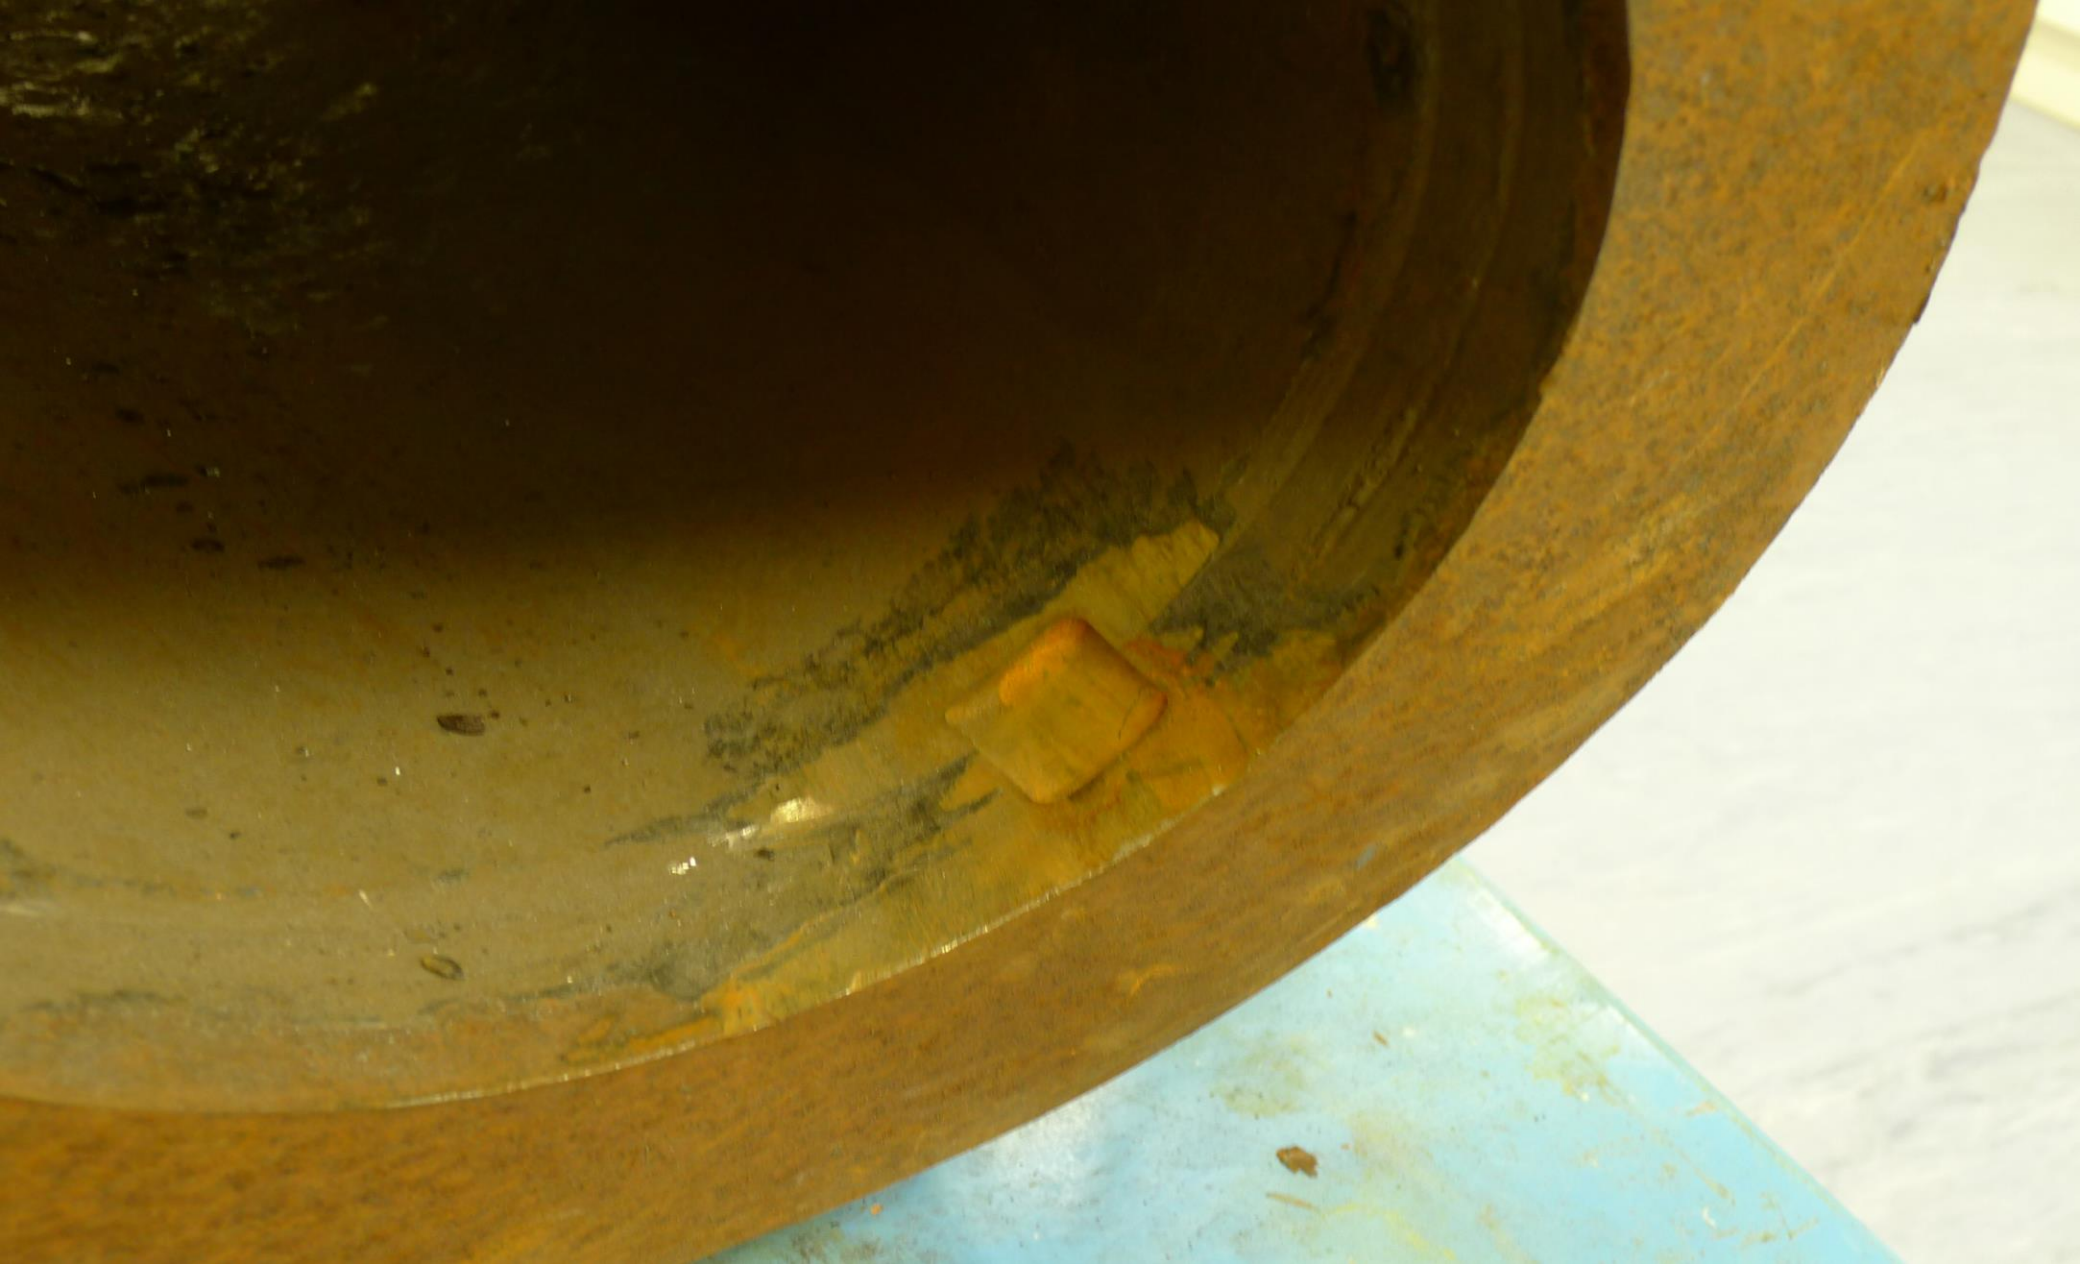
From top left (clockwise): EDSE cutting a sample from the reducer pipe; 4mm thick piece cut out from the pipe; round edge cavity left behind

Cutting electrode

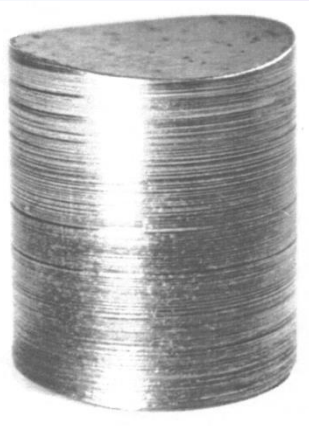
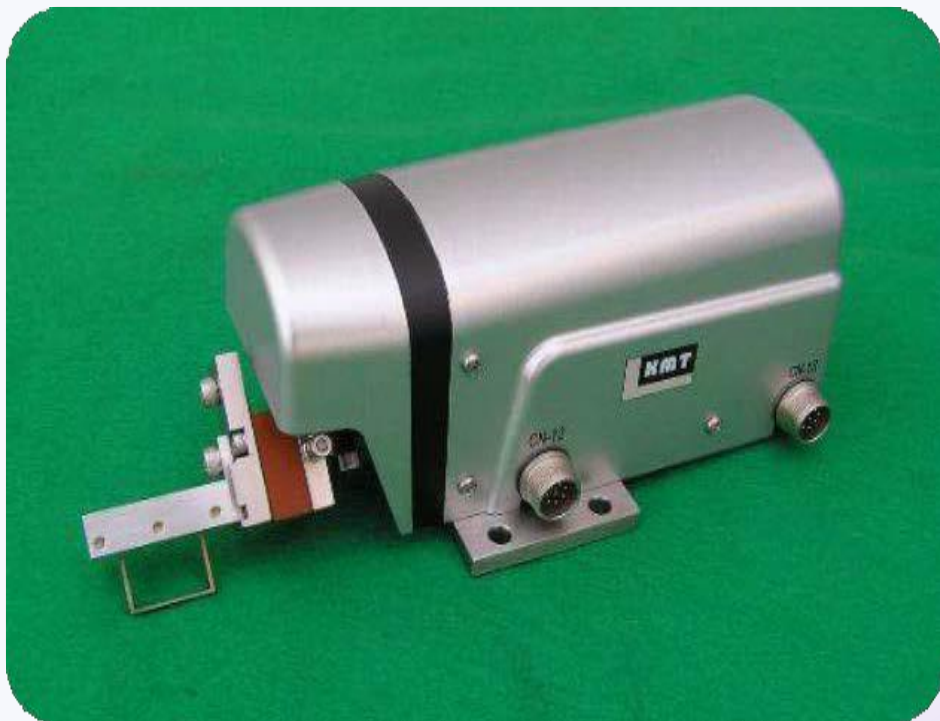
# Plug Trepanning - *old traditional method*

- Supplies a through-wall sample
  - Typically used for metallurgical investigation
  - Miniature samples can be extracted
  - Repair by welding blind stub over hole
  - Not taken from worst position
  - Mark up directions before cutting

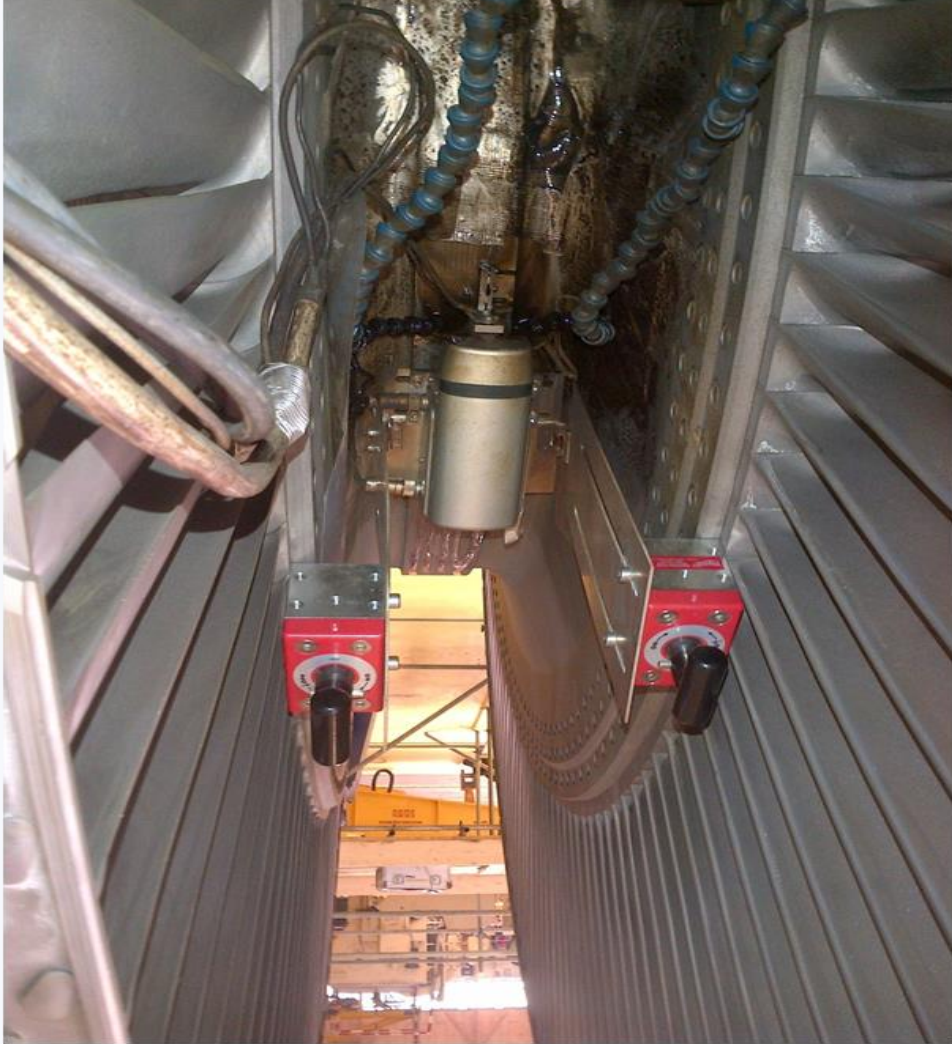
**EDSE mounted between 2 discs of a rotor using magnetic mounts (red tops).**

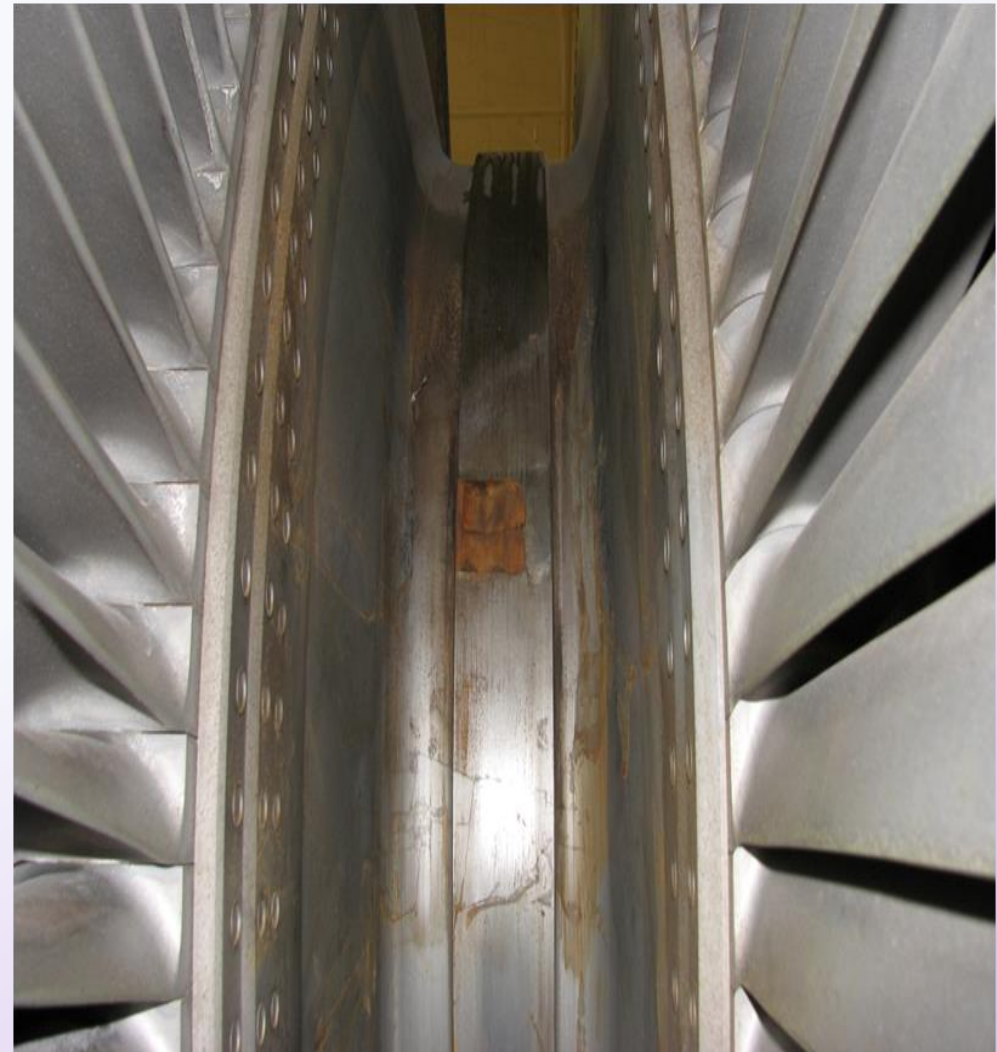
**Sample cut from a rotor between two discs.**

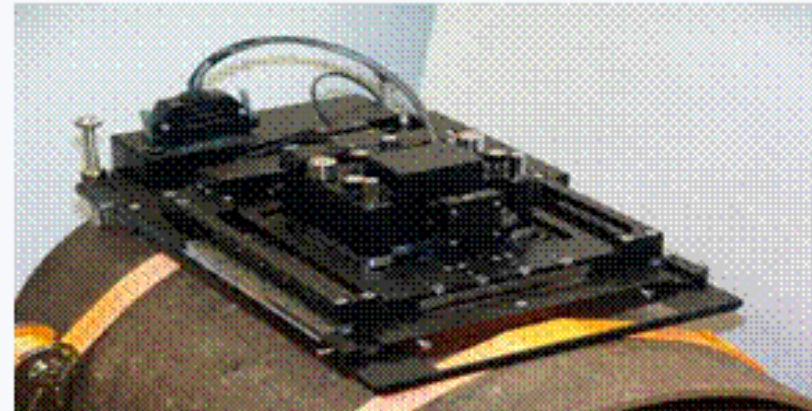
**New SFM with the mounting frame. Clockwise from top left: Schematic with the mounting frame, SFM mounted on a horizontal pipe, SFM enclosed in a box for safe keeping in plant during use, SFM mounted on a vertical pipe**

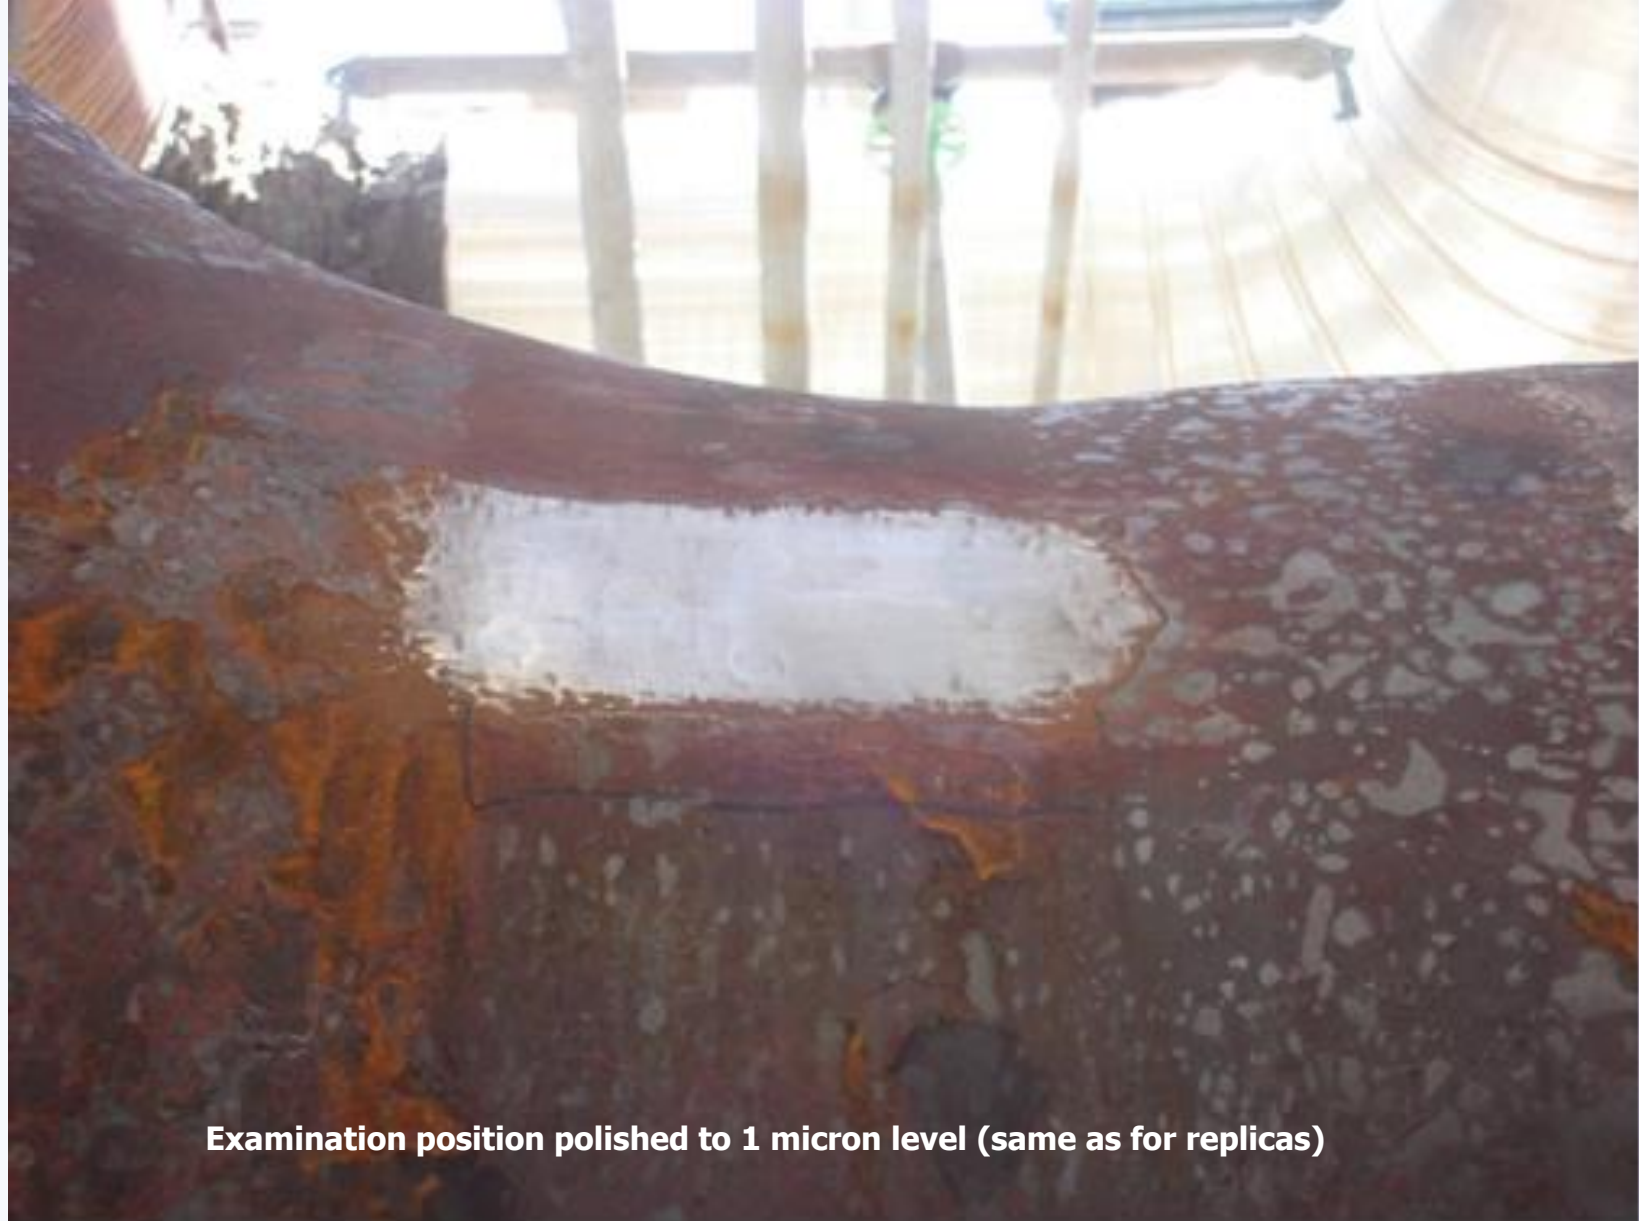
**Examination position polished to 1 micron level (same as for replicas)**

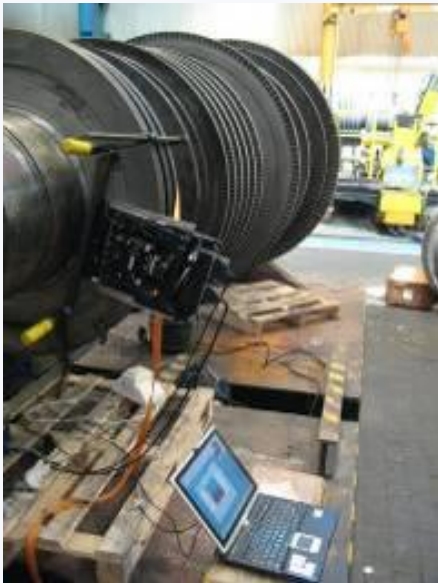
1<sup>st</sup> Stage of Rotor

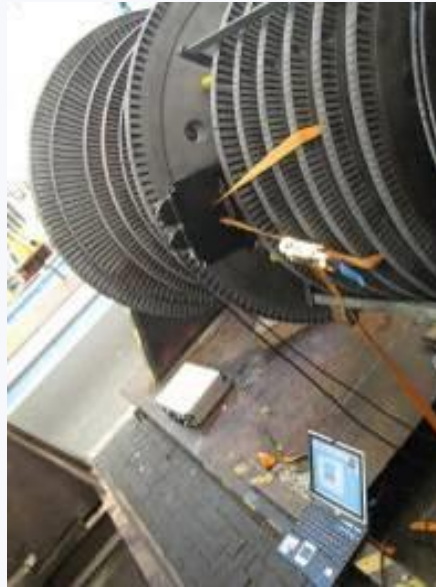
2<sup>nd</sup> Stage of Rotor

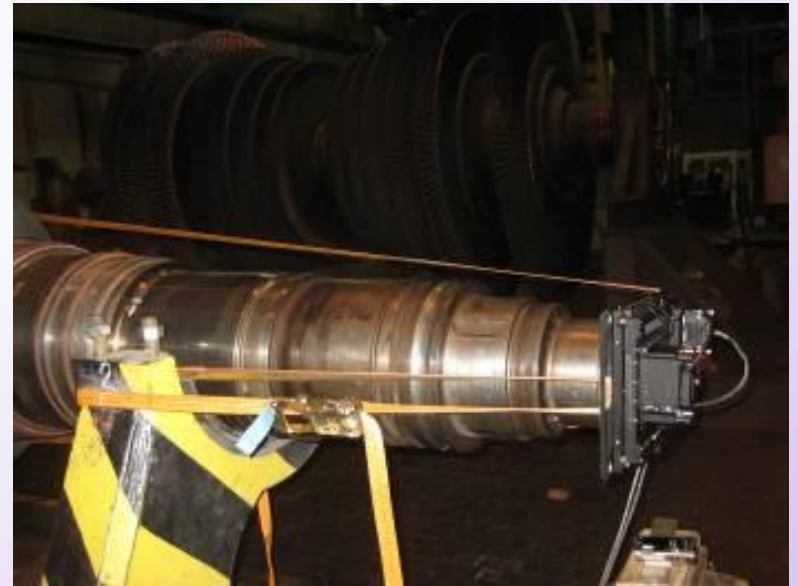
Rotor Hot Section End

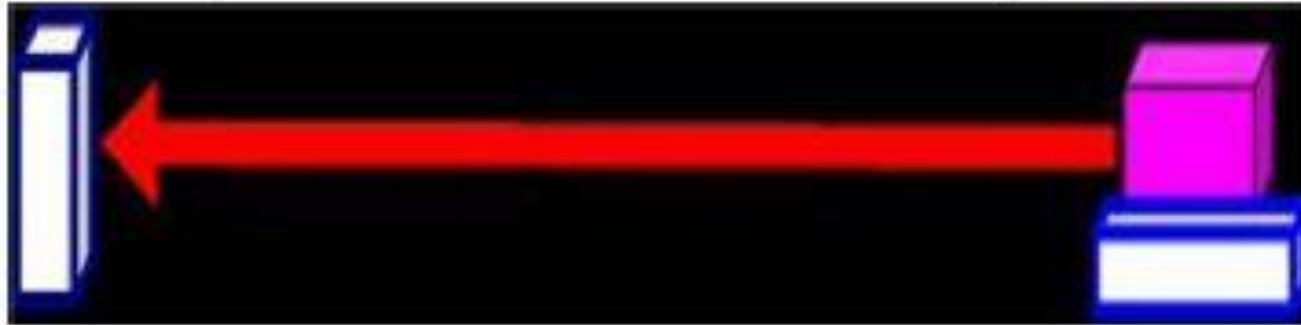
**Schematic of in-service strain measurement method**

- The strain rate is calculated based on measurements made using LSG at successive outages.
- The remaining life of the component is calculated using appropriate published relationships linking the strain rate to the creep rupture life of the material.

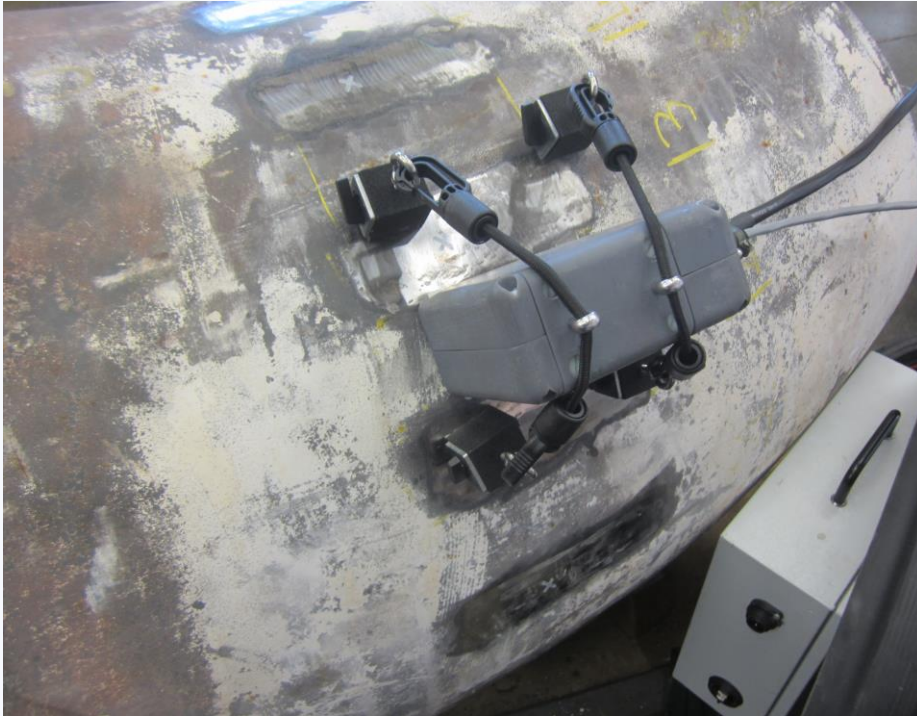
# Equipment set-up

- The equipment can be mounted in fixed positions around the pipe by permanent magnets and scan the target regions.
- The scanning results can be read instantaneously.
- Two frequency modes can be operated: 1 Hz and 0.1 Hz.

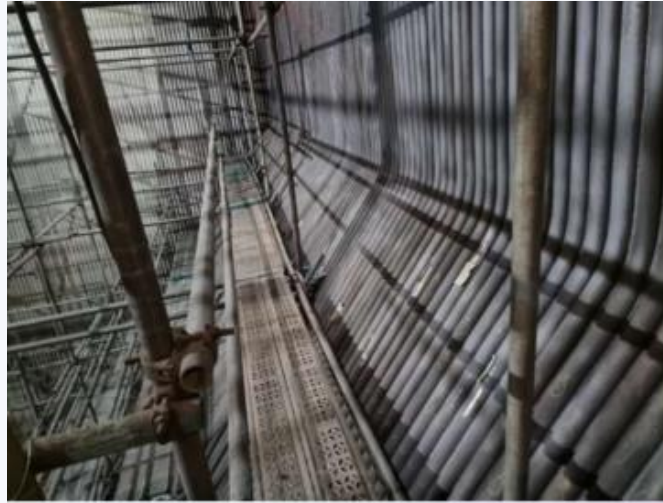
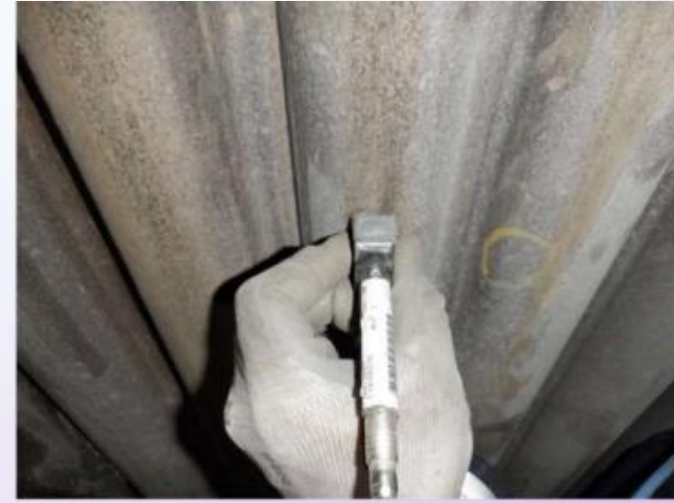
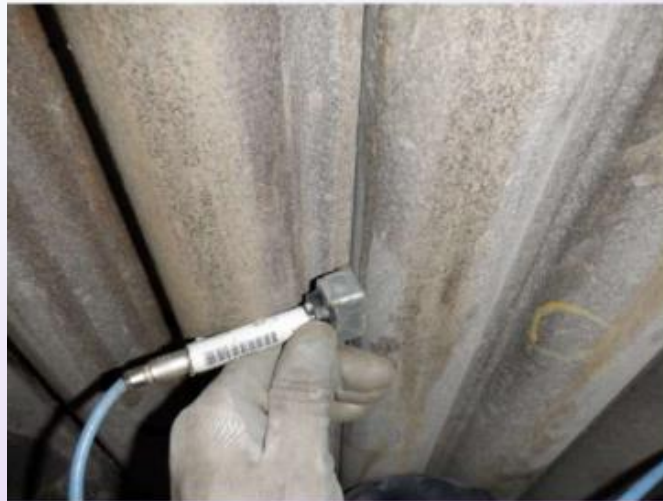
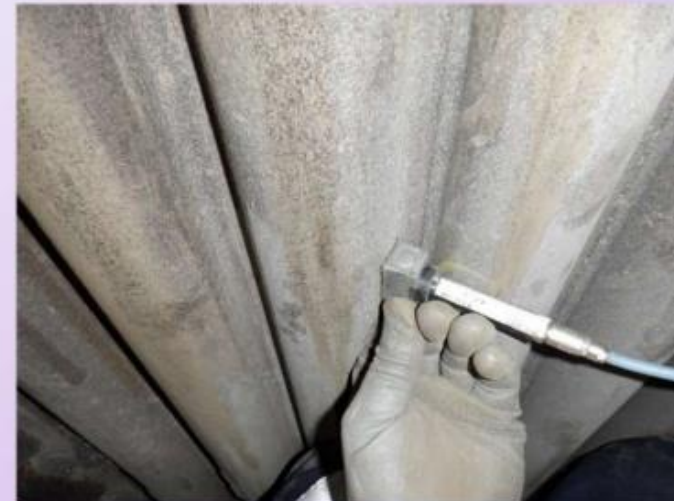
- Wall tubes in hopper area.
- > 500 tubes.
- Tubes scanned from top to bottom over a length of about 1.8 meters.
- 3 scans per tube.
